Ponderosa Revitalization Project

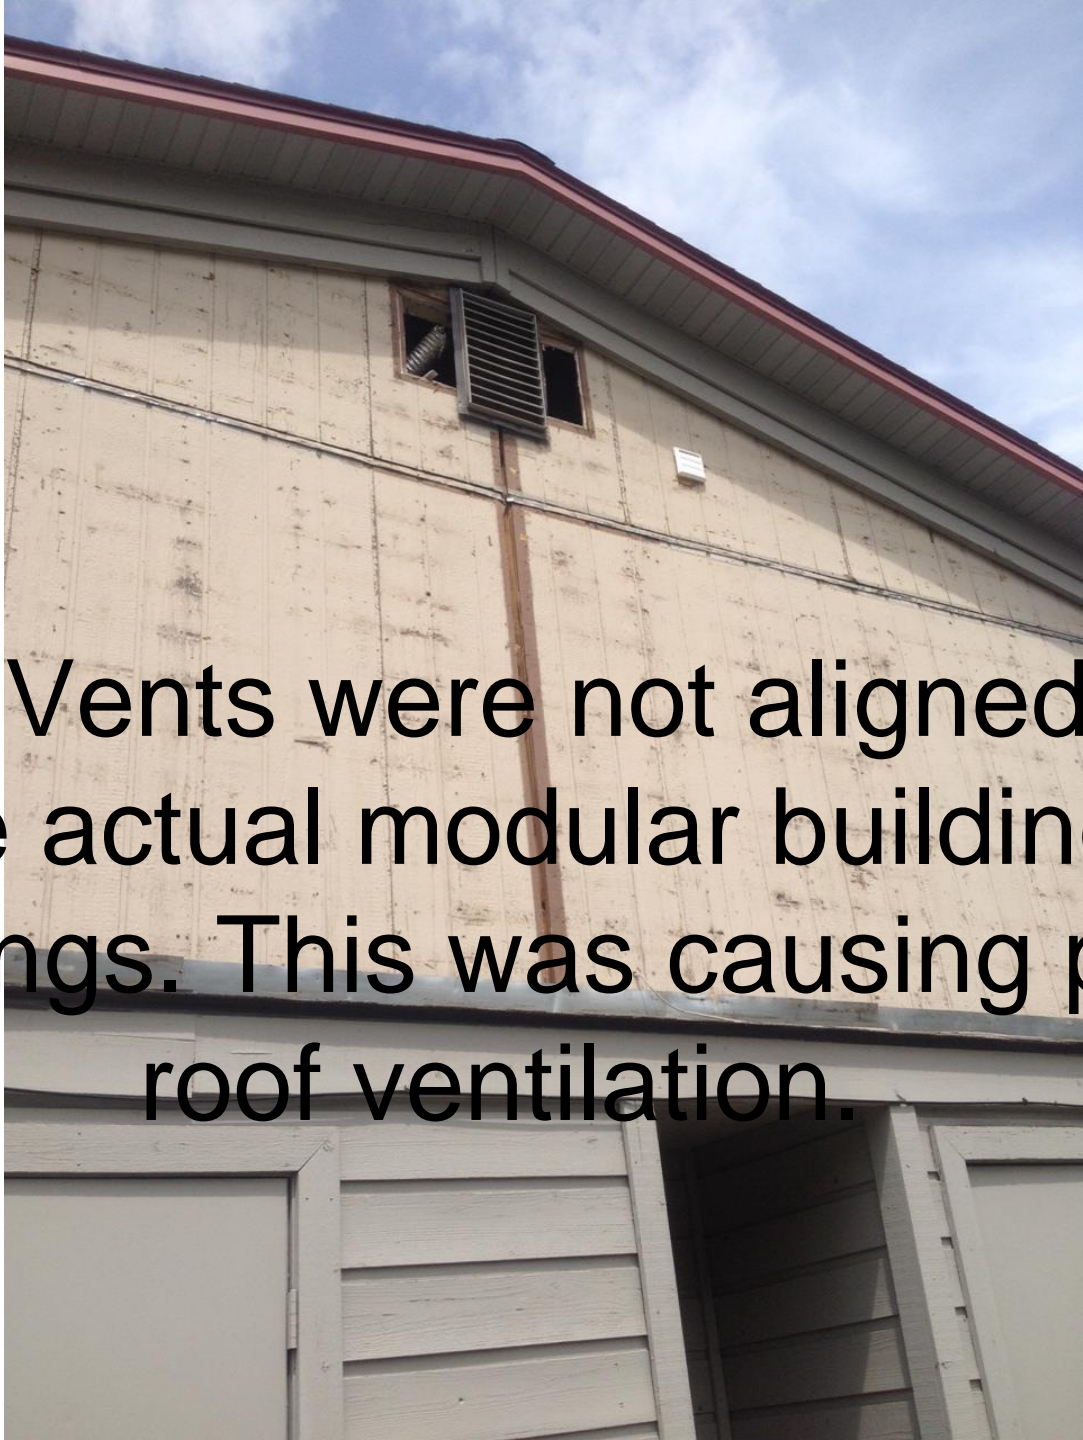
Gable Vents were not aligned with the actual modular building openings. This was causing poor roof ventilation.

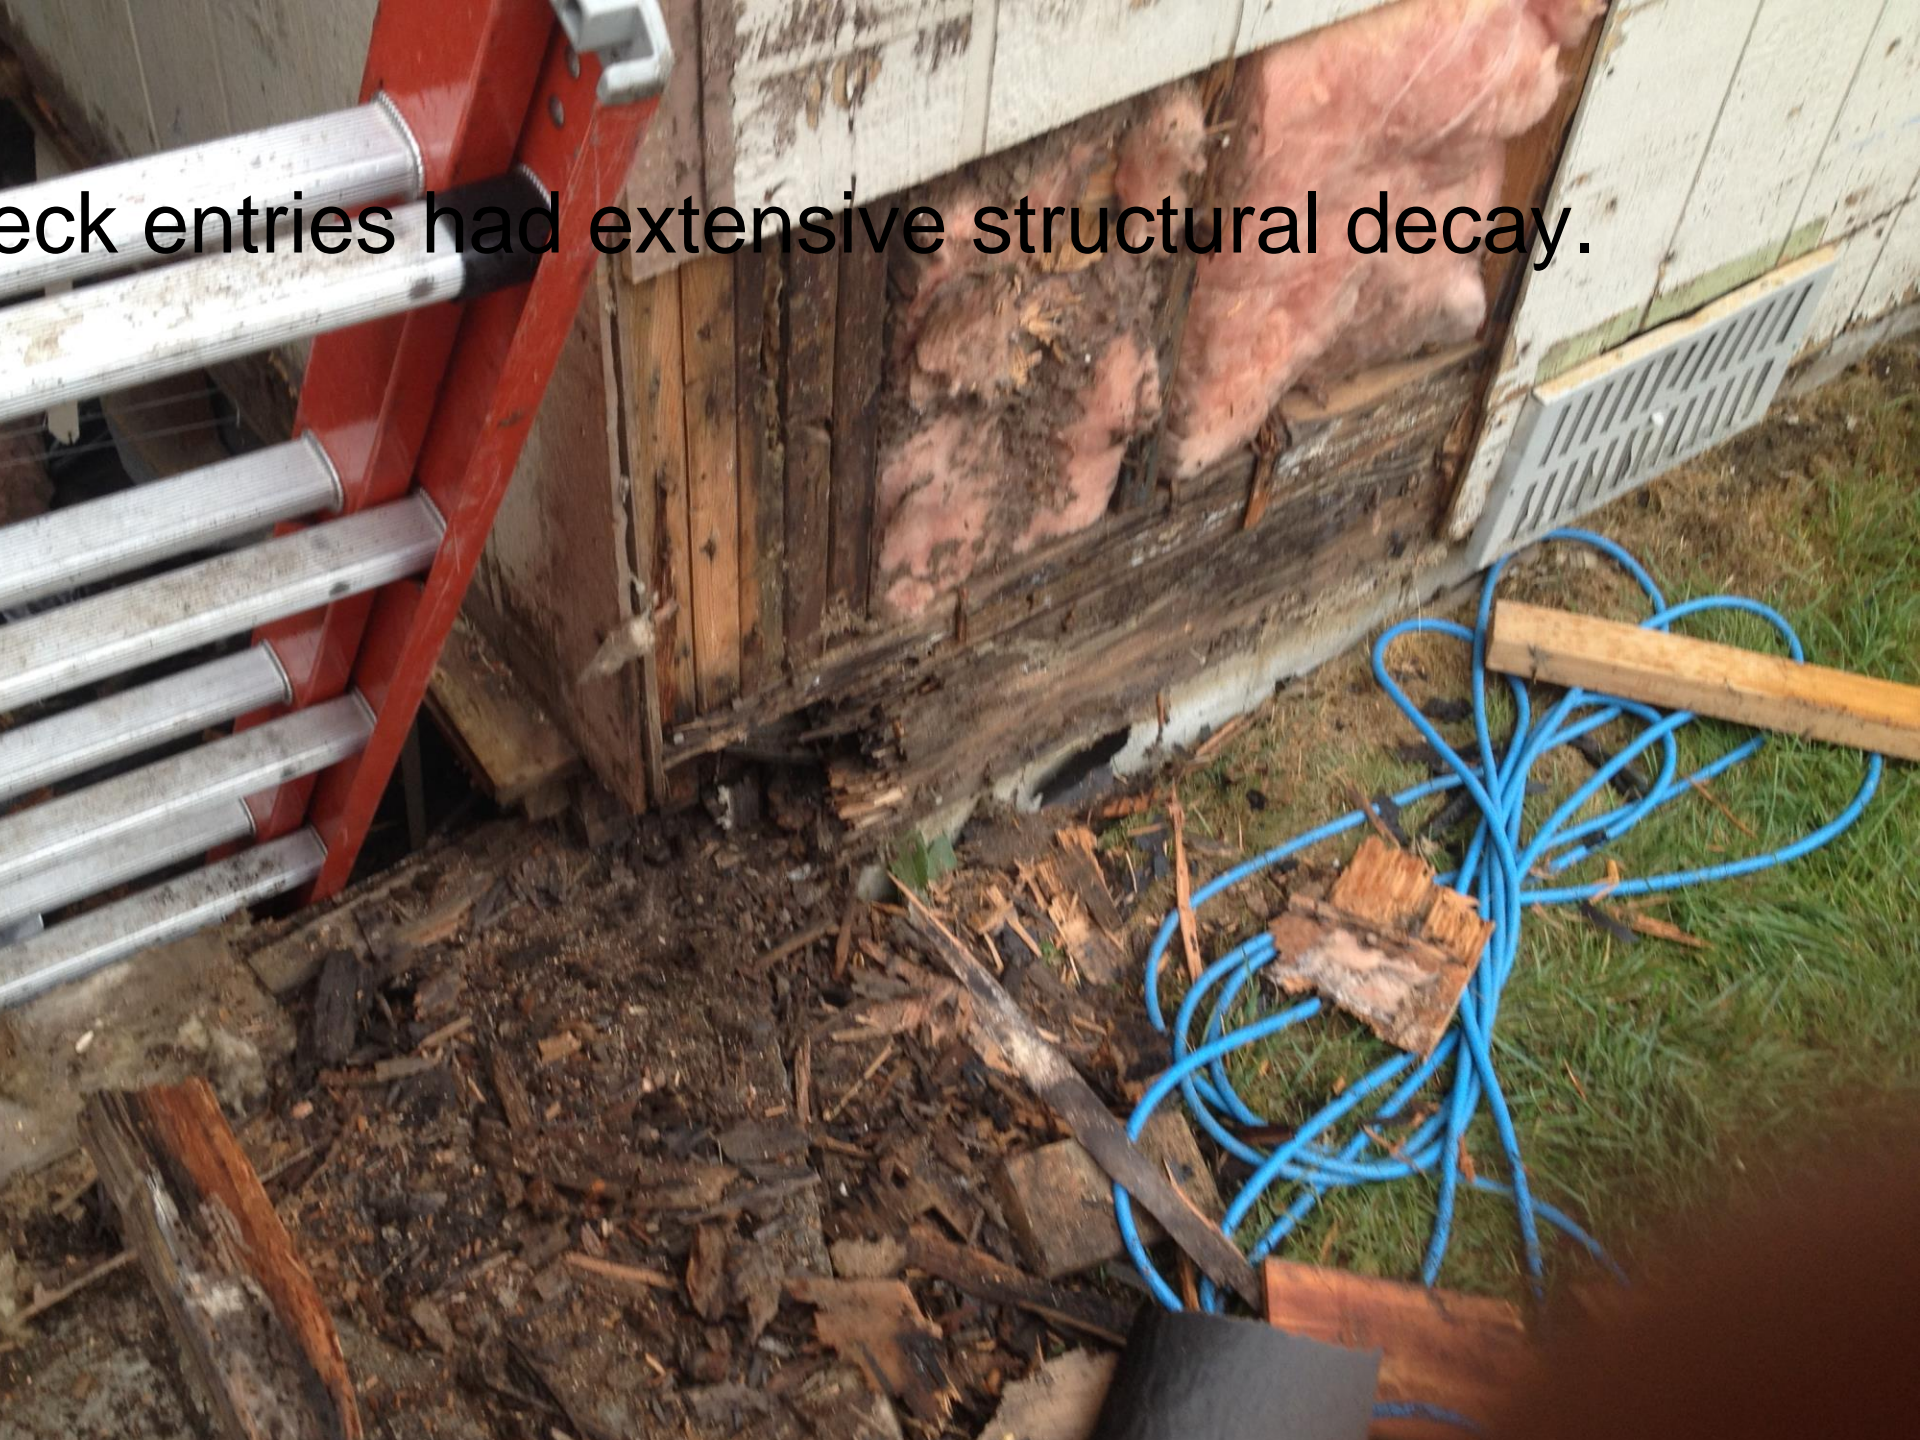
Deck entries had extensive structural decay.

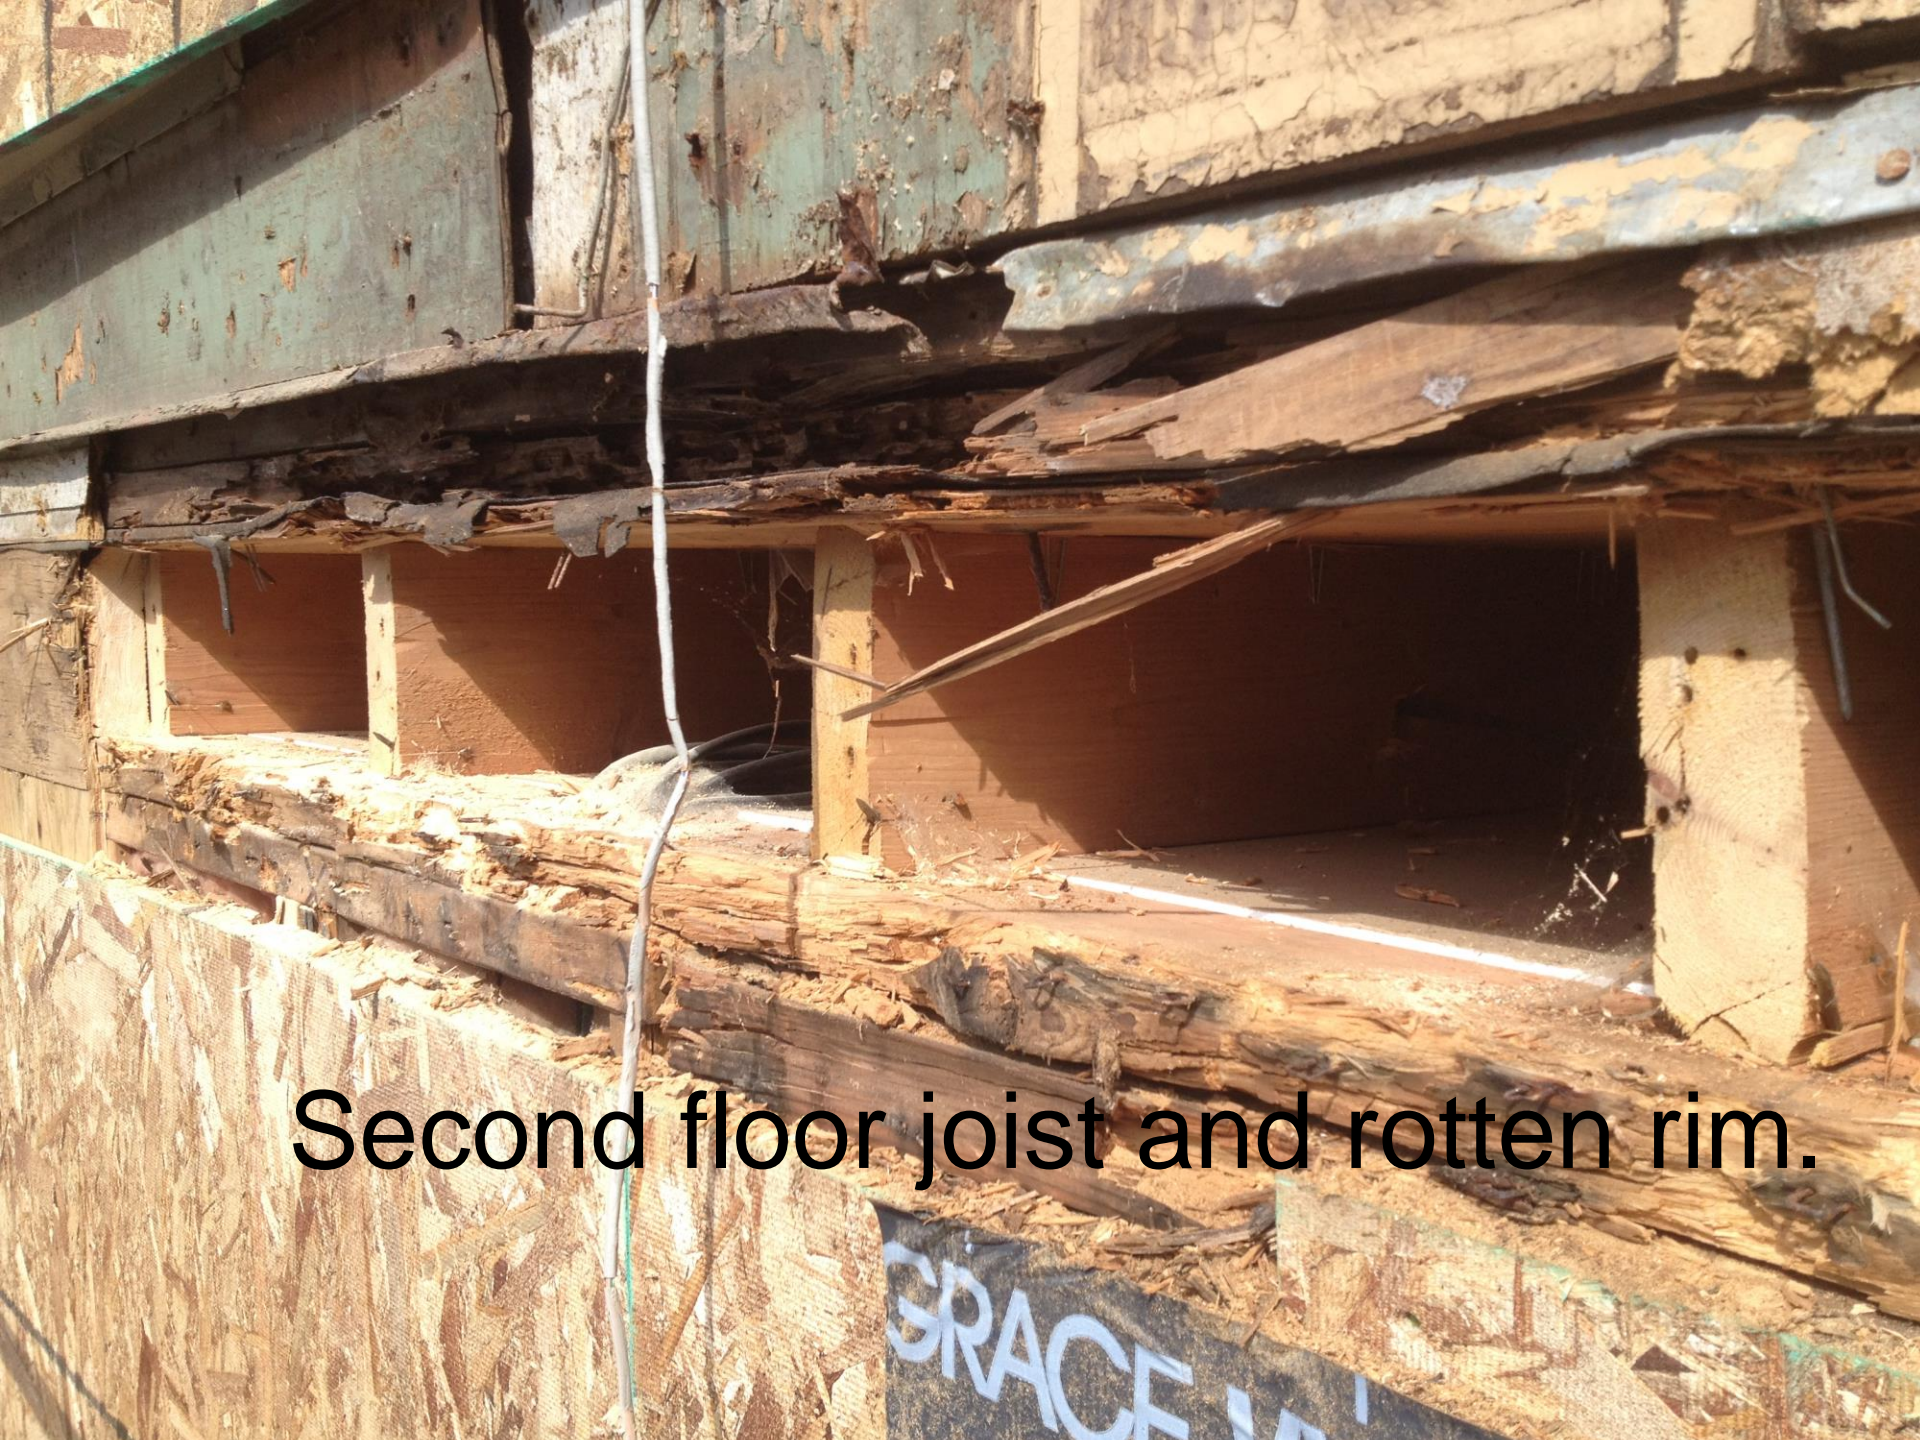
Second floor joist and rotten rim.

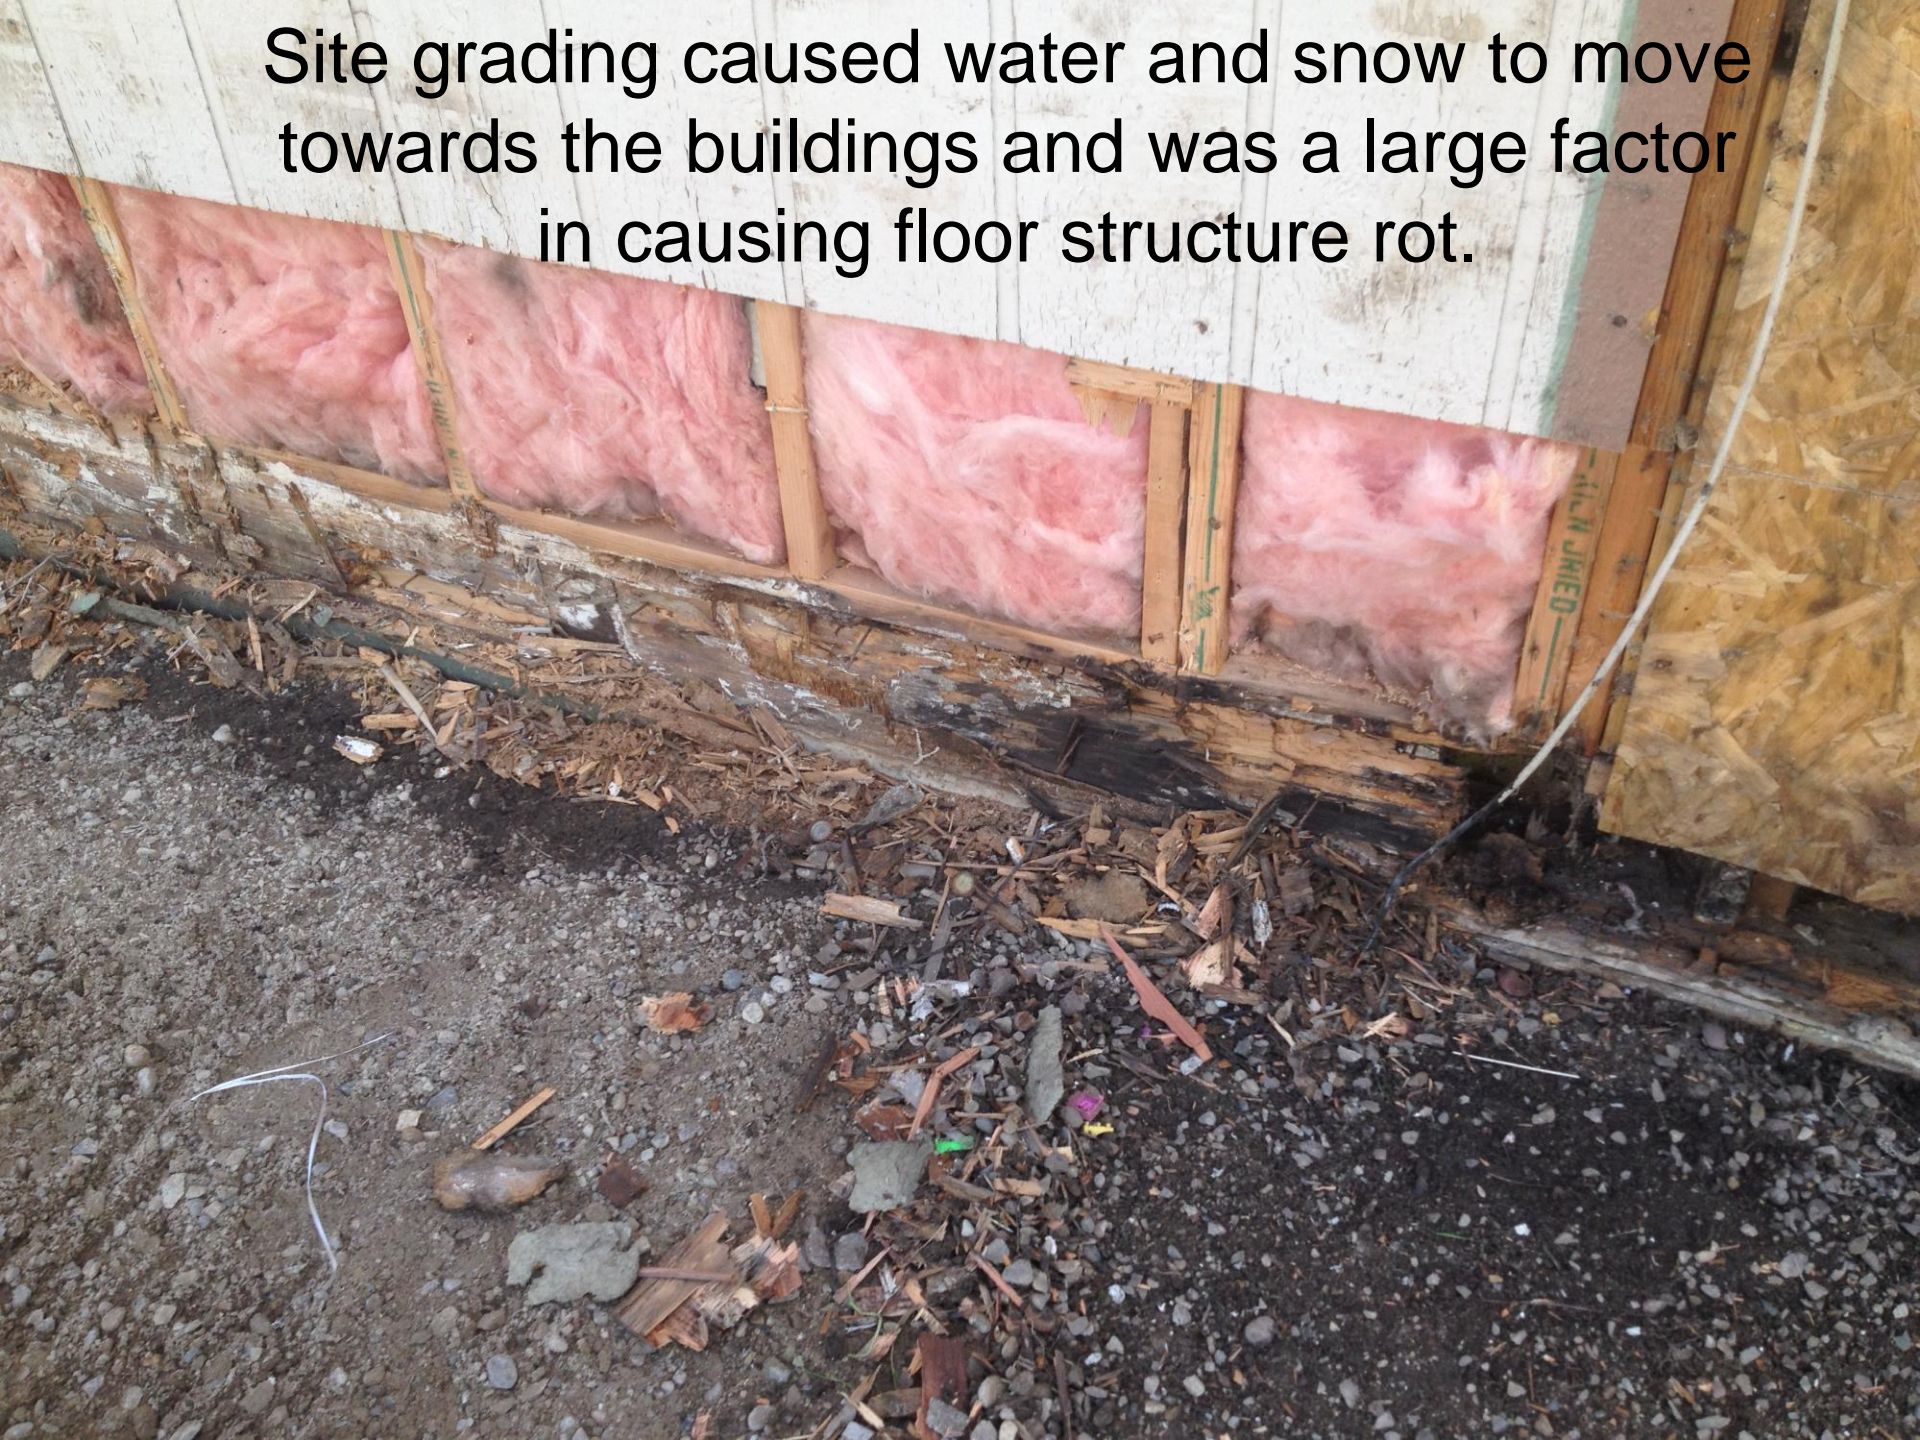
Site grading caused water and snow to move towards the buildings and was a large factor in causing floor structure rot.

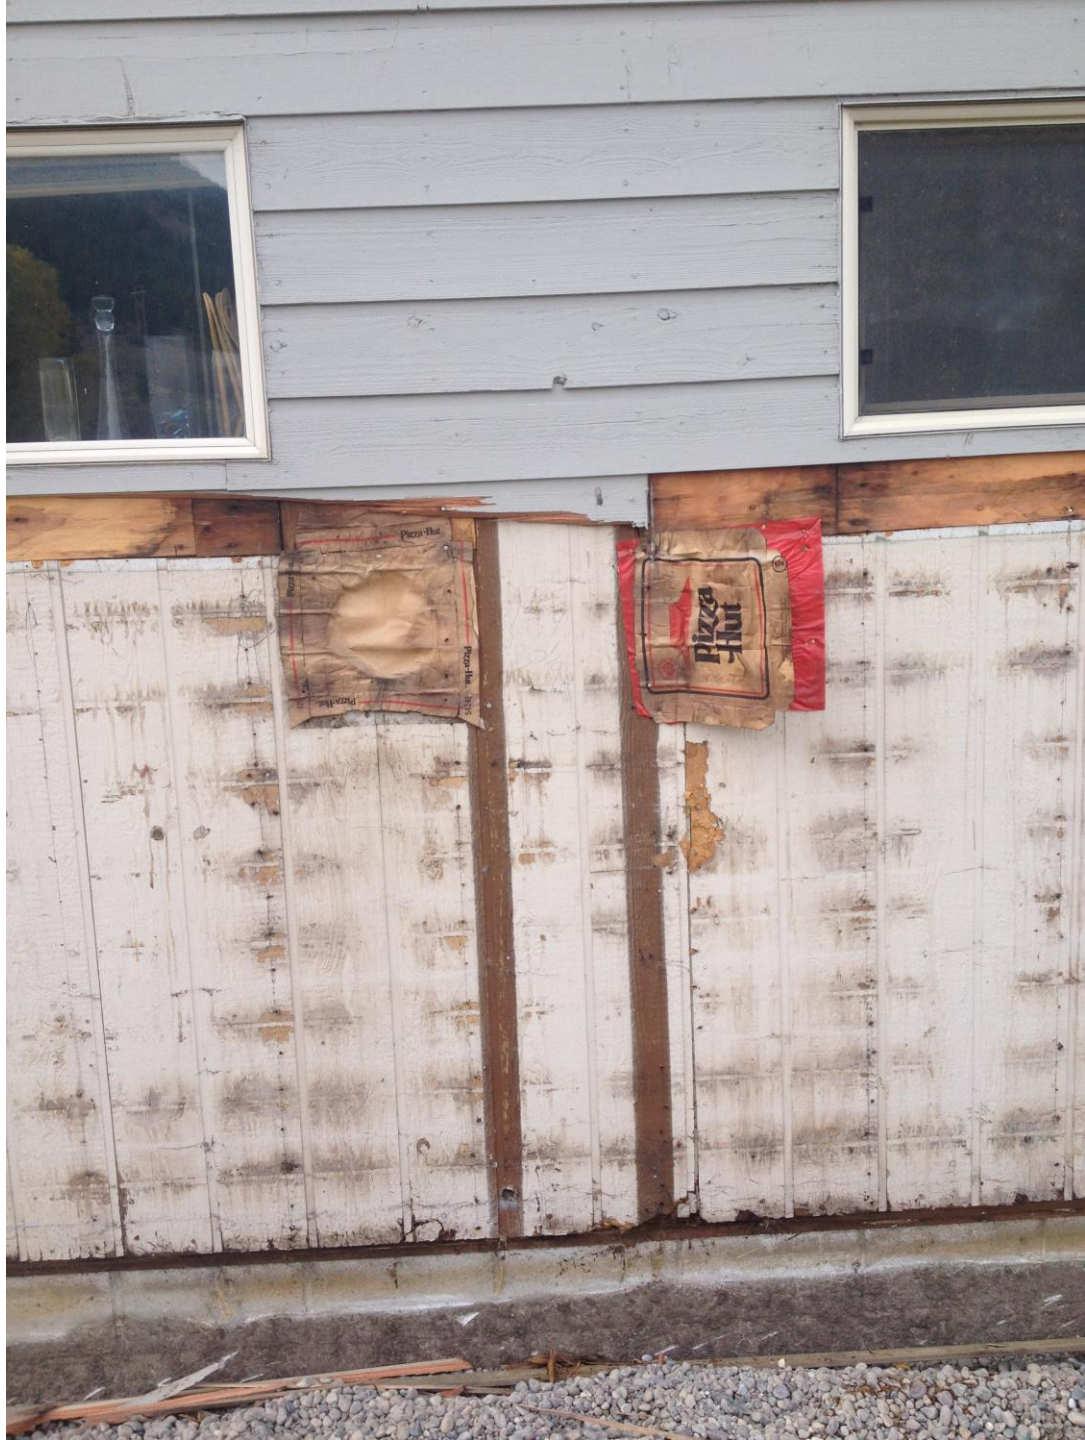
Many buildings had to be shimmed
because of initial modular
placement.
